Contract #: 04-0120F4Cty: SF/ALA Rte: 80 PM: 13.2/13.9File #: 69.28**WELDING INSPECTION REPORT****Resident Engineer:** Siegenthaler, Peter**Address:** 333 Burma Road**City:** Oakland, CA 94607**Report No:** WIR-020808**Date Inspected:** 27-Oct-2010**Project Name:** SAS Superstructure**OSM Arrival Time:** 700**Prime Contractor:** American Bridge/Fluor Enterprises, a JV**OSM Departure Time:** 1900**Contractor:** Zhenhua Port Machinery Company, Ltd (ZPMC), Changxing Island **Location:** Shanghai, China**CWI Name:** Li Yan Hua**CWI Present:** Yes No**Inspected CWI report:** Yes No N/A**Rod Oven in Use:** Yes No N/A**Electrode to specification:** Yes No N/A**Weld Procedures Followed:** Yes No N/A**Qualified Welders:** Yes No N/A**Verified Joint Fit-up:** Yes No N/A**Approved Drawings:** Yes No N/A**Approved WPS:** Yes No N/A**Delayed / Cancelled:** Yes No N/A**Bridge No:** 34-0006**Component:** OBG Segment Assembly**Summary of Items Observed:**

OBG Segment 12AW

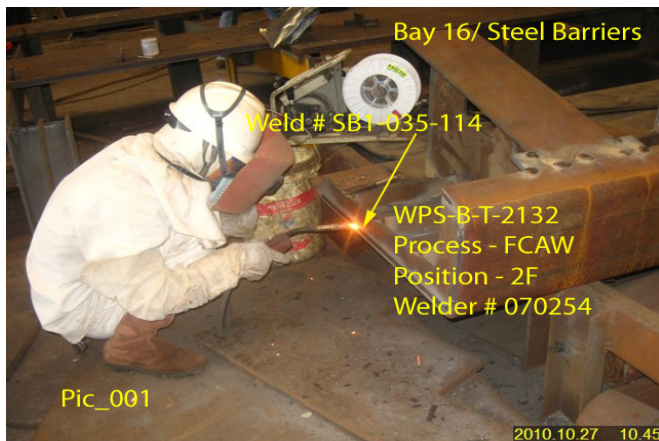
Flux Core Arc Welding (FCAW) in the 2F position of W5-SB1D-008 Steel Barrier internals weld # SB1-035-114. The welder is identified as 070254. ZPMC Quality Control (QC) is identified as Guo Pin. The welding variables recorded by QC appeared to comply with WPS-B-T-2132. See attached photograph Pic_001.

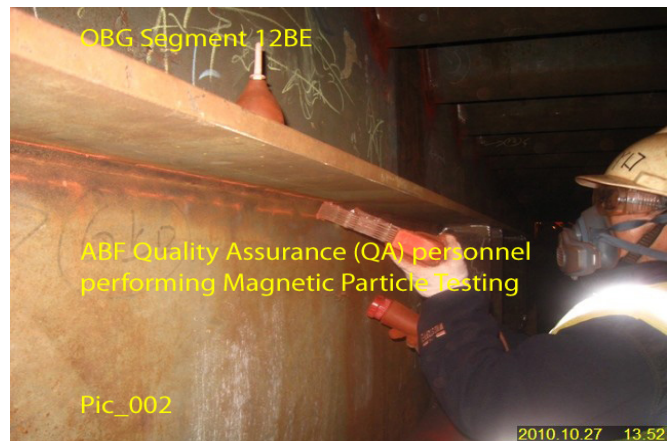
During in process inspection this QA Inspector observed ABF Quality Assurance (QA) personnel performing Magnetic Particle Testing (MT) on Deck Panel Diaphragm to Flange weld at PP112W. See attached photograph Pic_002.
